# 'Sealing the deal': An innovative use of the endotracheal cuff manometer

Canadian Journal of Respiratory Therapy

Vol. 61, 2025

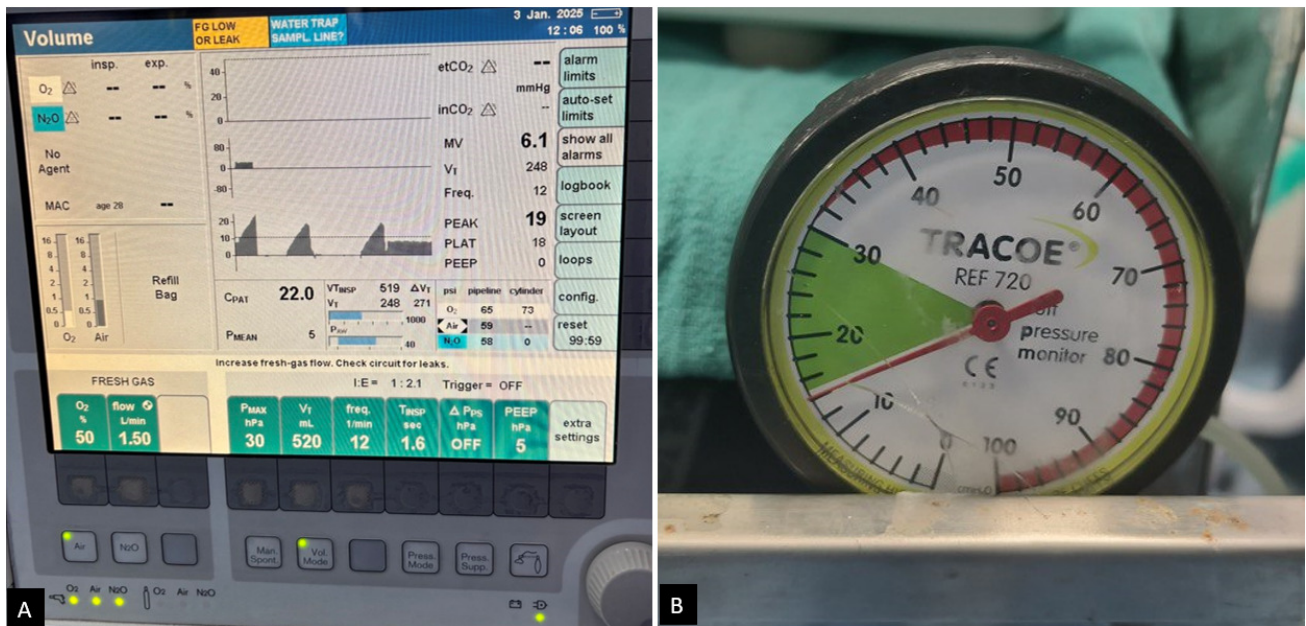
One hour into surgery, the ventilator alarm indicated a fresh gas flow leak and failure to deliver the set tidal volume, with a detected leak of 200-300 mL per cycle. Increasing the tidal volume did not resolve the issue ([Figure 1](#)). Since the problem was addressed immediately, the patient remained hemodynamically stable with no desaturation. Examination of the ETT revealed a deflated pilot balloon. Manual inflation with a syringe temporarily reduced the leak and restored adequate ventilation. However, the issue recurred after 10 minutes, raising suspicion of ETT cuff malfunction.

Figure 1. A) Ventilator alarm indicating fresh gas flow leak; B) Cuff Manometer showing low cuff pressures.

To facilitate intraoperative management, the pilot balloon was connected to a 2-meter extension line, with the distal end attached to a cuff pressure manometer (Tracoe Cuff Pressure Monitor Sensitive, Atos Medical, UK) ([Figure 2](#)). This setup enabled continuous monitoring of ETT cuff pressure and allowed for repeated inflation whenever the pressure dropped below 20 cm H<sub>2</sub>O or a fresh gas flow leak was detected. This innovative approach provided quantitative cuff pressure assessment and ensured adequate intraoperative ventilation. As the ventilatory leak decreased, replacing the ETT intraoperatively was deemed unnecessary. Throughout the nine-hour surgery, adequate minute ventilation was maintained with stable hemodynamic parameters and arterial blood gas values. No episodes of desaturation or hypoxia occurred.

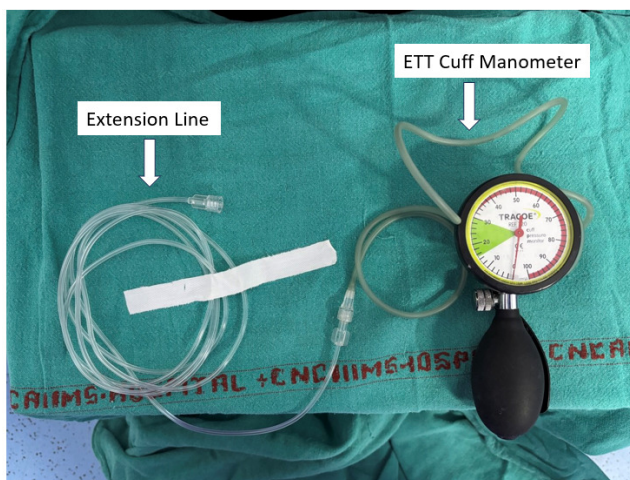
Figure 2. The distal end of the ETT cuff manometer is attached to the 2-metre extension system, which is then connected to the ETT inflation system.

In our case, the ETT leak was attributed to a malfunction of either the cuff or the pilot balloon and inflation system. Connecting the pilot balloon to a 2-meter extension line attached to a cuff pressure manometer not only allowed for repeated inflation but also enabled continuous monitoring of cuff pressure, facilitating early detection of even minor leaks. This approach also prevented manual overinflation, which can cause tracheal mucosal injury and increase the risk of postoperative sore throat. Although various techniques have been described for managing similar airway complications, none have incorporated continuous ETT cuff pressure monitoring using a manometer. This method provides real-time quantitative assessment and management of ETT leaks. While multiple management strategies exist, literature on addressing such complications in the prone position remains scarce. Prompt, innovative thinking and skilled management are crucial for ensuring patient safety and surgical success in these situations.
